# **SURVEY OF ASBESTOS- CONTAINING MATERIALS**

HOWARD WIGGLESWORTH PUBLIC  
SCHOOL (GARY ALLAN)

96 GUELPH STREET, GEORGETOWN, ONTARIO

December 20, 2018

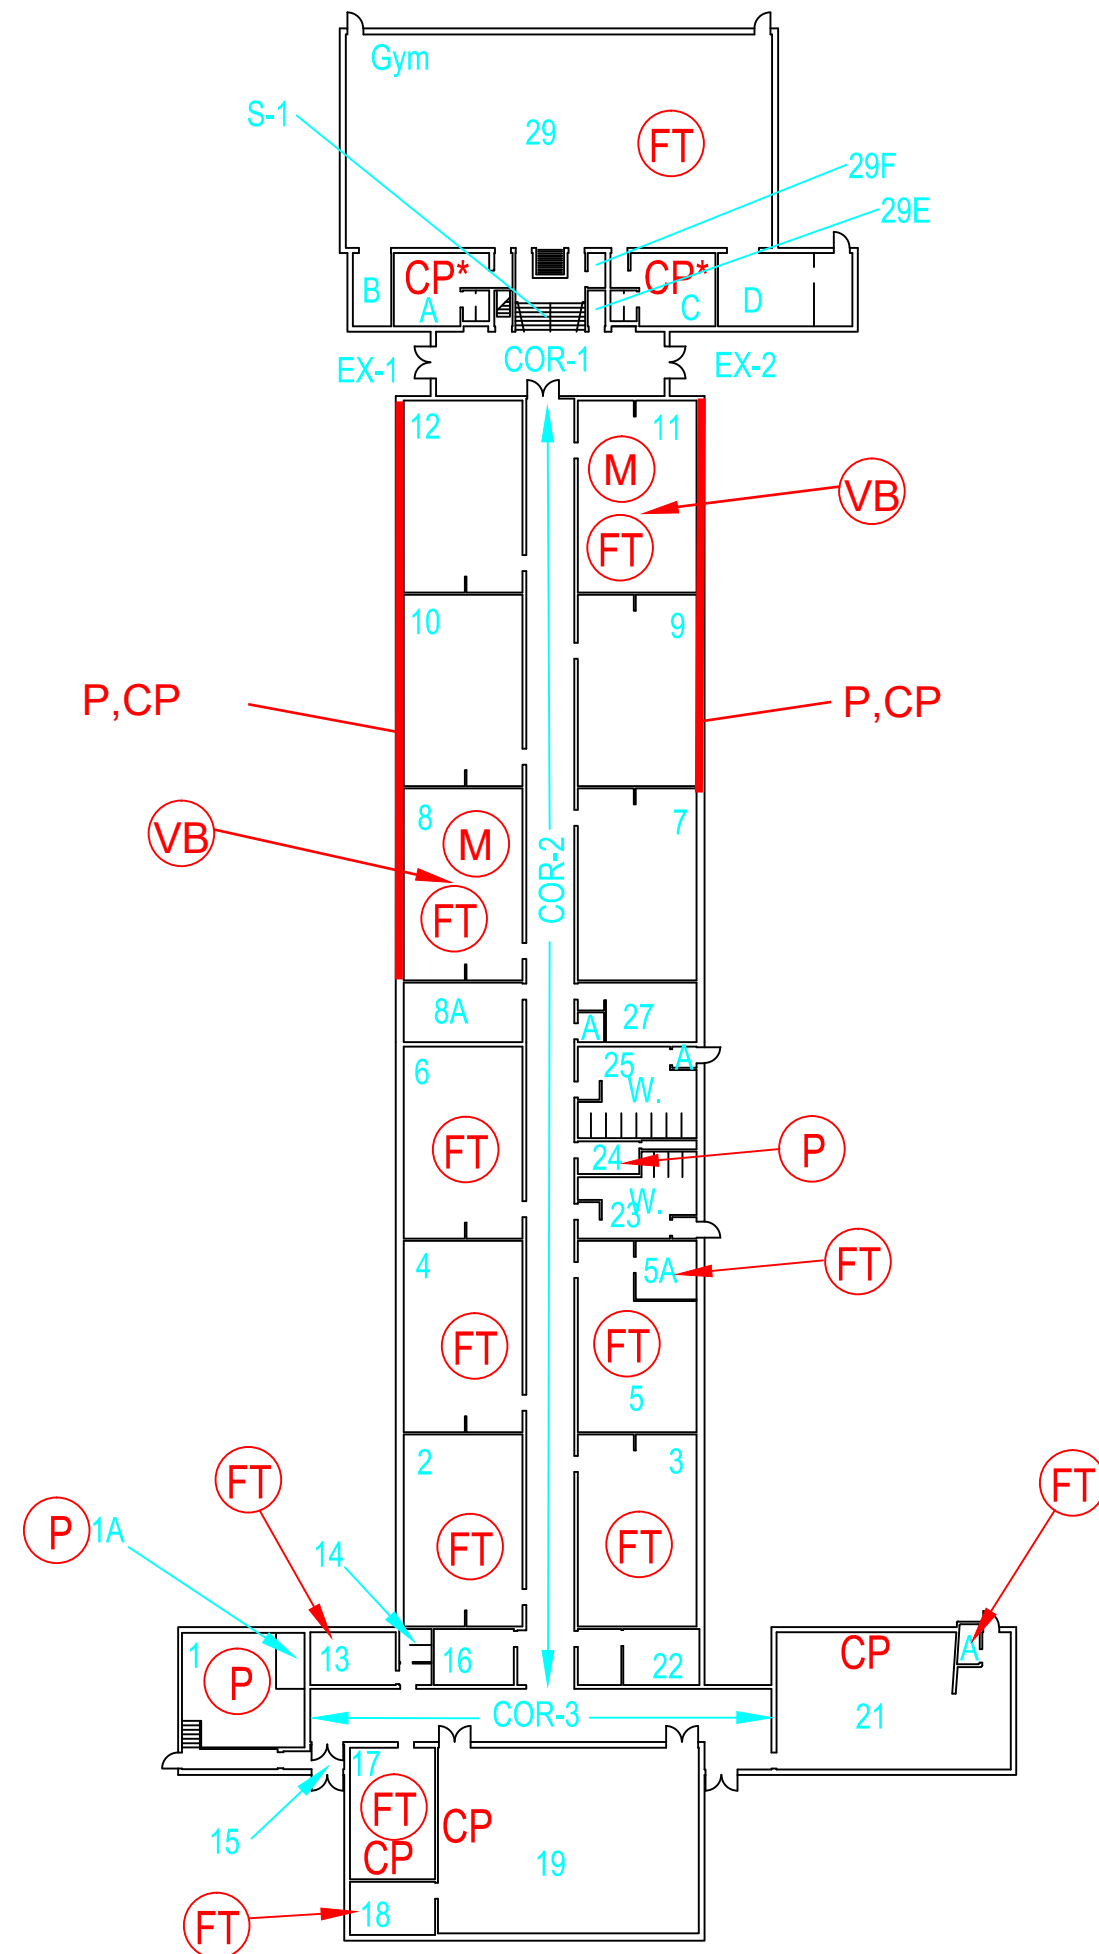
## Floor Plans

A room-by-room summary of the locations and conditions of asbestos-containing materials identified is presented in Table 3.2. The locations of accessible asbestos containing materials are identified on the floor plans provided in Appendix A.
