**REPORT
TO
THE HALTON DISTRICT SCHOOL BOARD**

**SURVEY AND ASSESSMENT OF
ASBESTOS-CONTAINING MATERIALS
JOSEPH GIBBONS PUBLIC SCHOOL
GEORGETOWN, ONTARIO**

Revised August 2013

701931-000

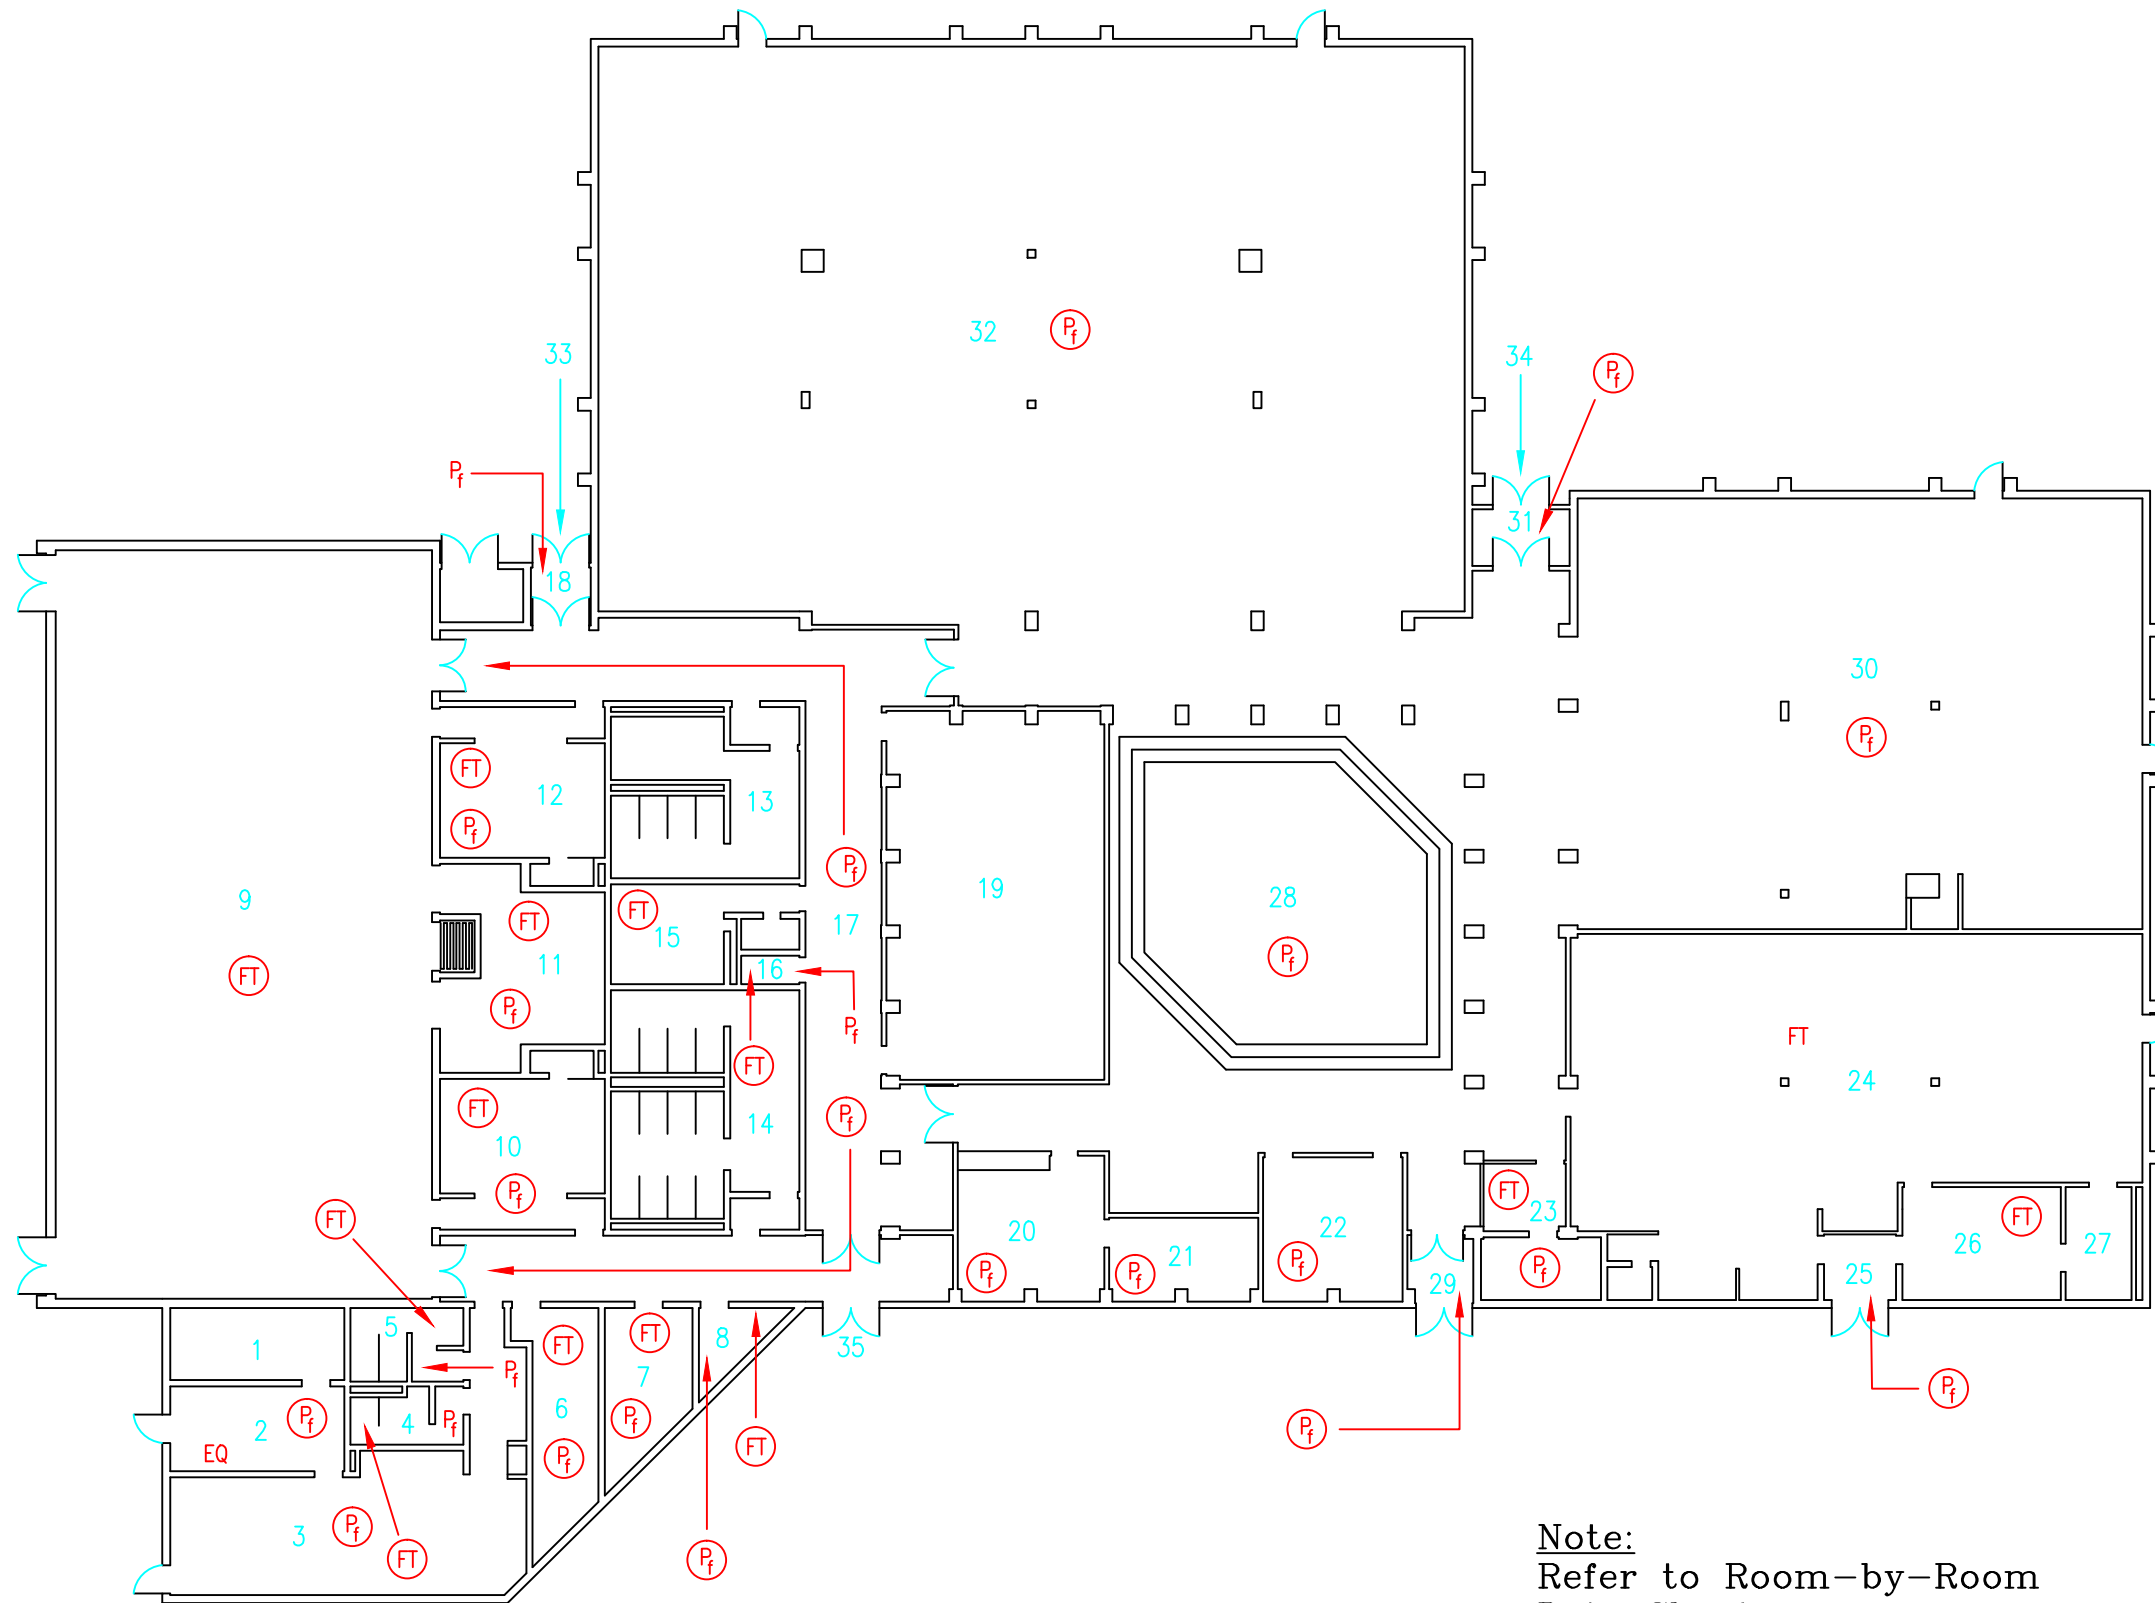
FIRST FLOOR

Note:
 Refer to Room-by-Room
 Data Sheets
 for specific locations of
 asbestos
 cement products.
