**REPORT  
TO  
THE HALTON DISTRICT SCHOOL BOARD**

**UPDATED SURVEY OF  
ASBESTOS-CONTAINING MATERIALS  
KILBRIDE PUBLIC SCHOOL  
6611 PANTON STREET  
KILBRIDE, ONTARIO**

March 2015

702170-019

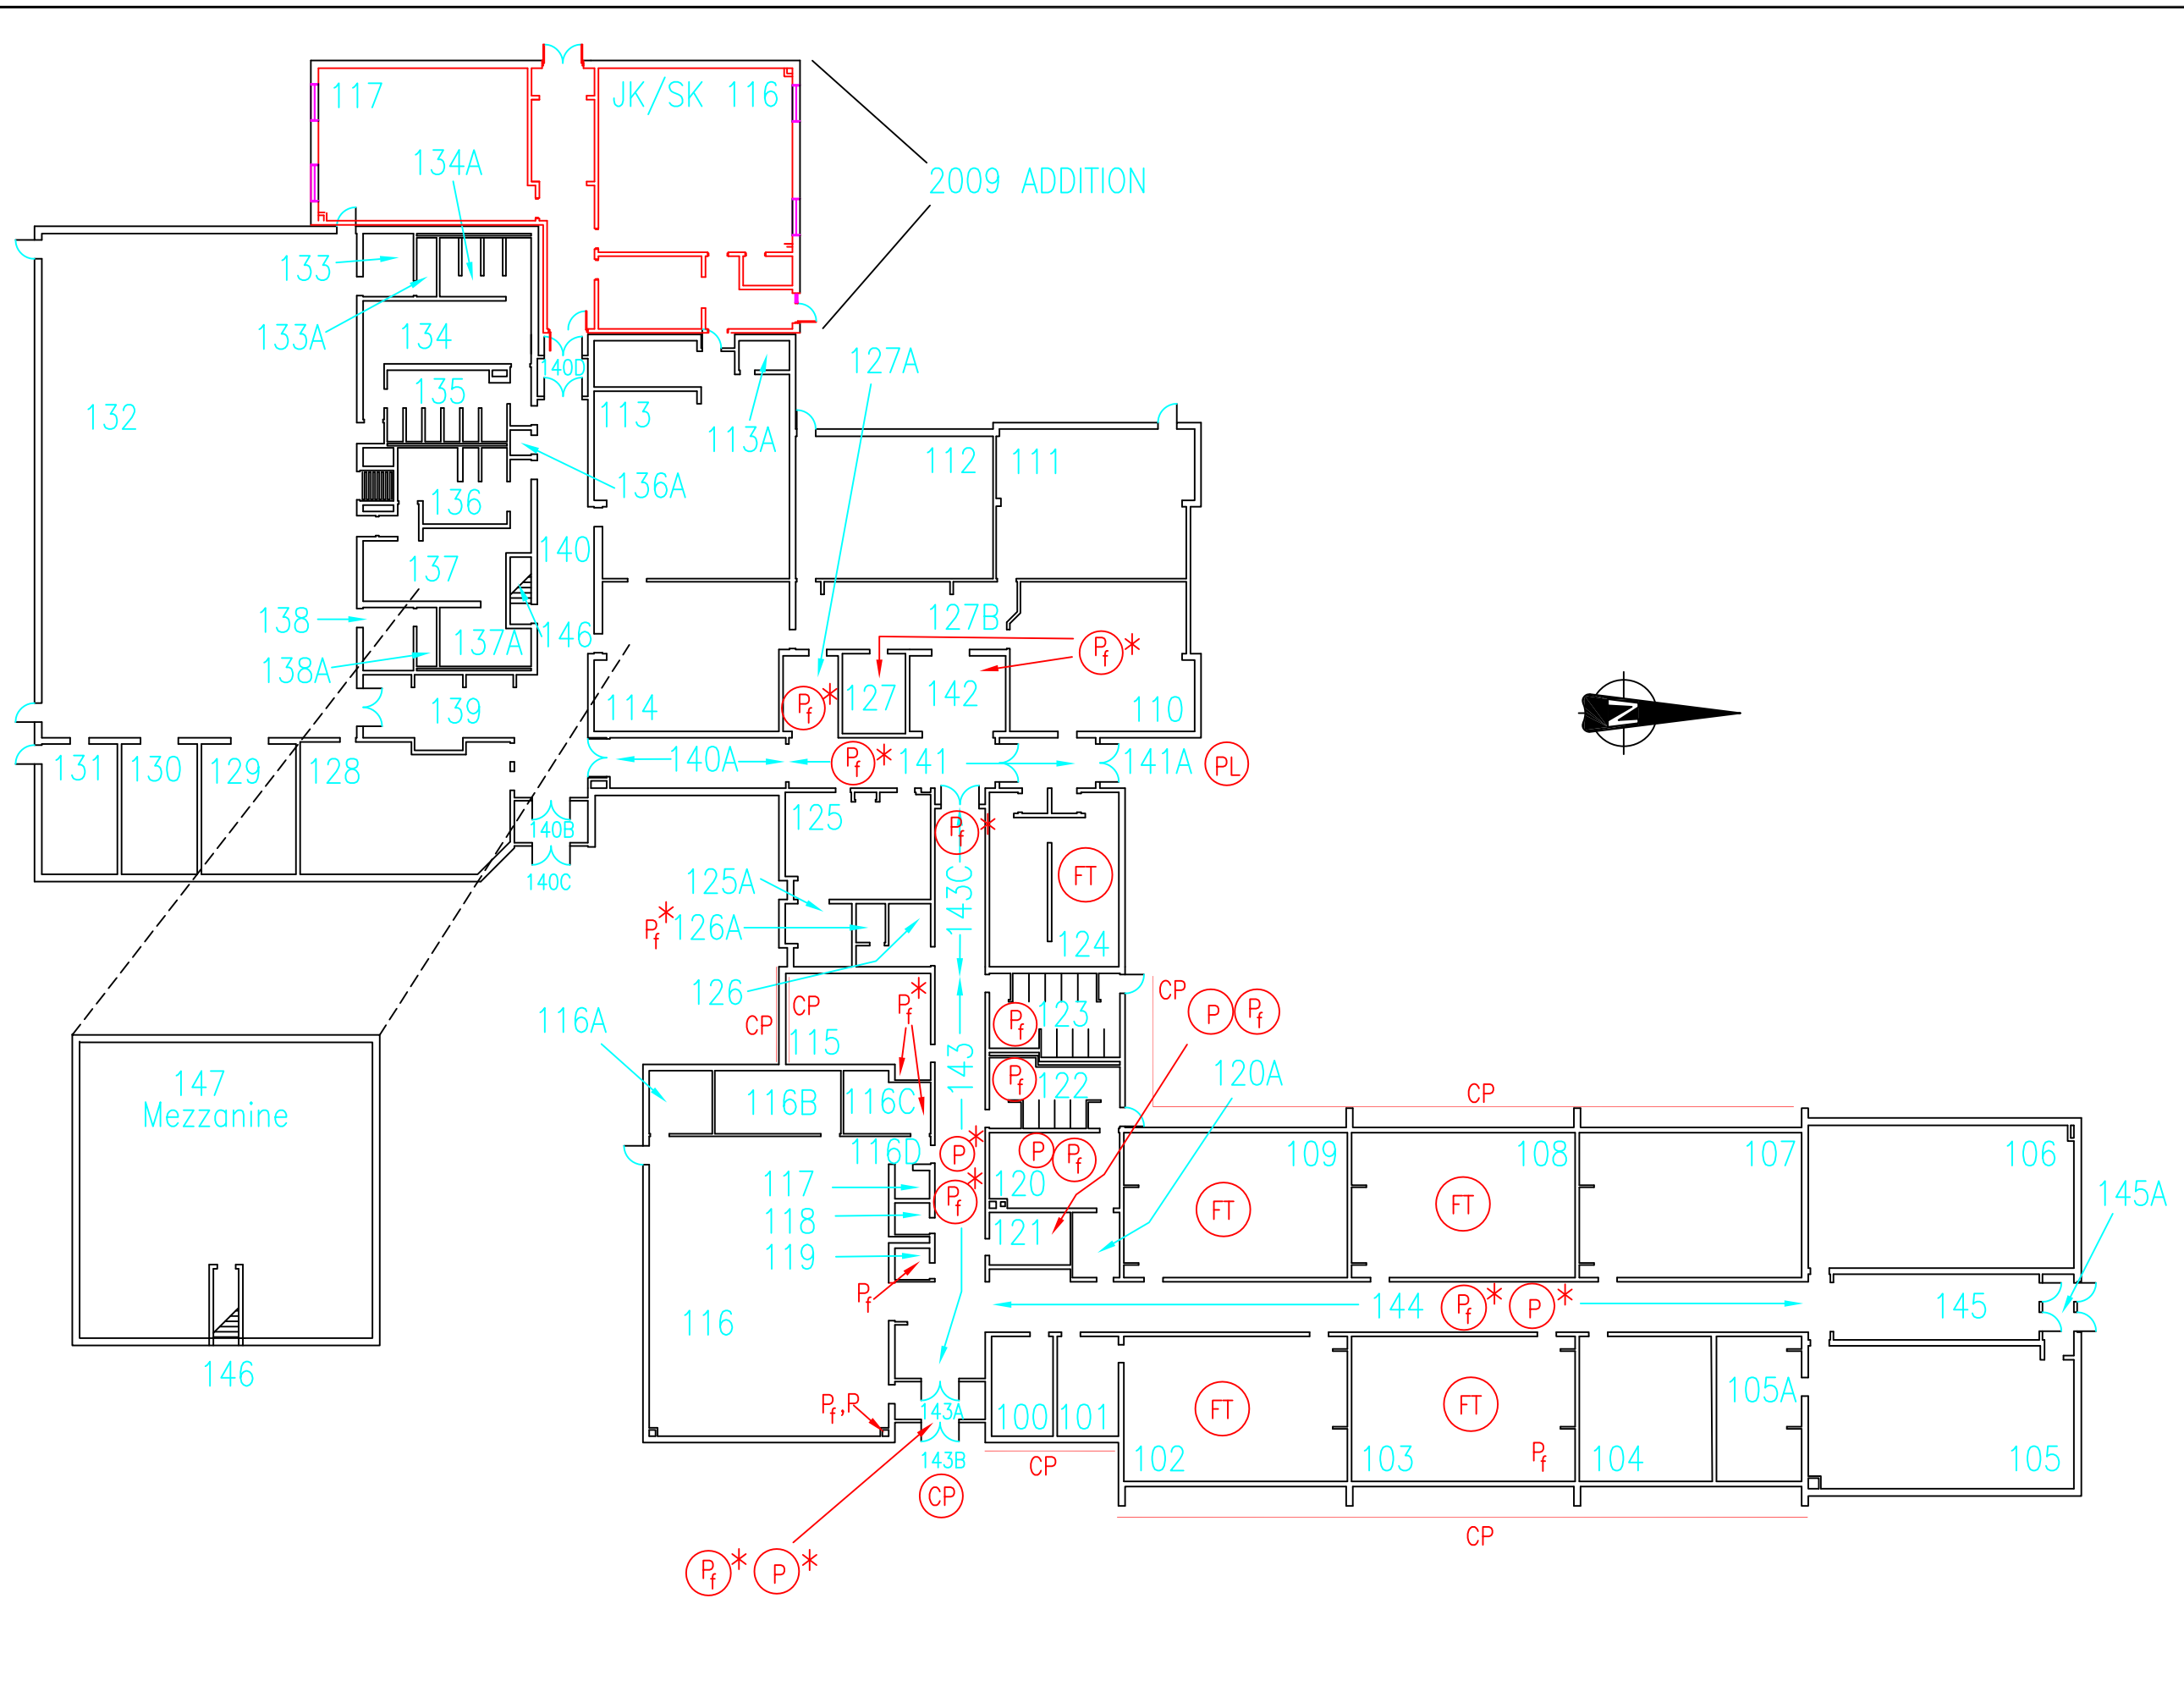
**DCS** AN ARCADIS COMPANY  
 DECOMMISSIONING CONSULTING SERVICES  
 HALTON DISTRICT SCHOOL BOARD  
**UPDATED SURVEY OF ASBESTOS-CONTAINING MATERIALS**  
 LOCATION OF ASBESTOS CONTAINING MATERIALS  
 KILBRIDE PUBLIC SCHOOL  
 6611 Panton Street, Kilbride, Ontario  
**FIRST FLOOR & MEZZANINE FLOOR**

A room-by-room summary of the locations and conditions of asbestos-containing materials identified is presented in Table 3.2. The locations of accessible asbestos-containing materials are identified on the floor plan provided in Appendix A. Various eras of construction are outlined on a floor plan also provided in Appendix A.

1. INTERIORS OF ALL FIRE DOORS ARE ASSUMED TO CONTAIN ASBESTOS.
