**REPORT
TO
THE HALTON DISTRICT SCHOOL BOARD**

**UPDATED SURVEY OF
ASBESTOS-CONTAINING MATERIALS
SAM SHERRATT PUBLIC SCHOOL
649 LAURIER AVENUE
MILTON, ONTARIO**

September 2014

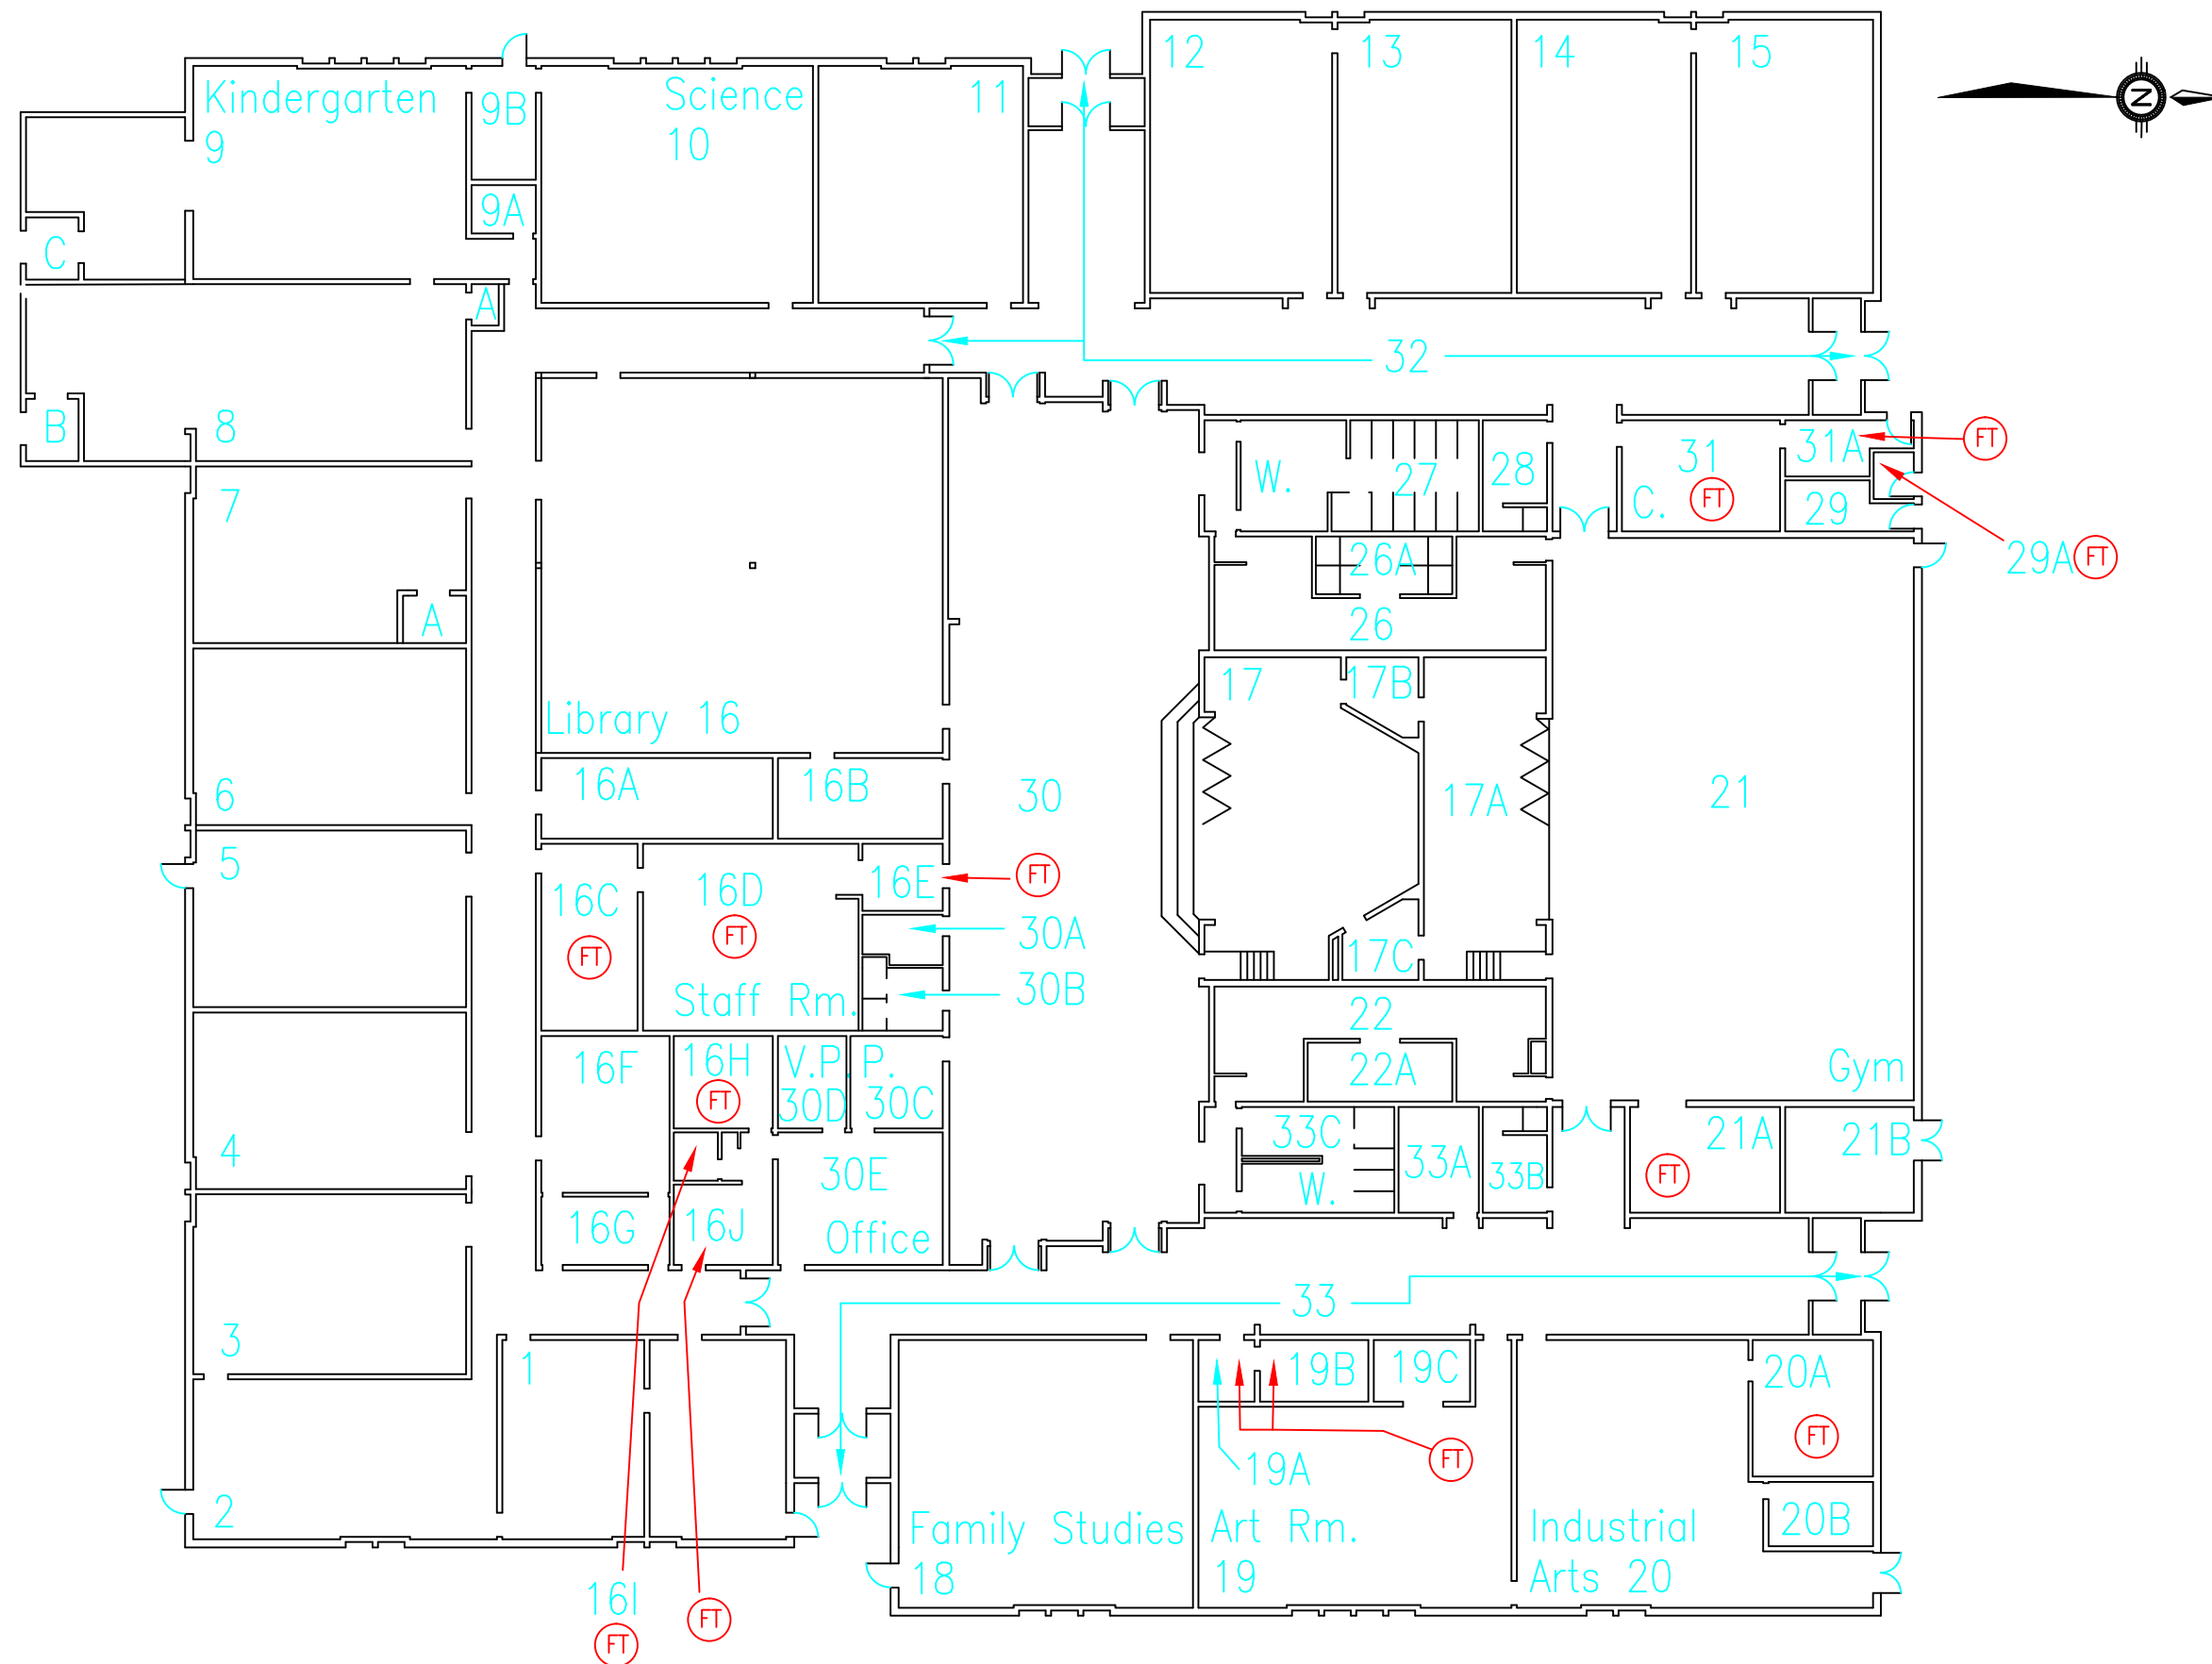
FLOOR PLANS

- 12” x 12” vinyl floor tiles in Rooms 16C, 16D, 16E, 16H, 16I, 16J, 19A, 19B, 20A, 21A, 29A, 31 and 31A.

A room-by-room summary of the locations and conditions of asbestos-containing materials identified is presented in Table 3.2. The locations of accessible asbestos-containing materials are identified on the floor plans provided in Appendix A.
