**REPORT
TO
THE HALTON DISTRICT SCHOOL BOARD**

**SURVEY AND ASSESSMENT OF
ASBESTOS-CONTAINING MATERIALS
SHERIDAN PUBLIC SCHOOL
OAKVILLE, ONTARIO**

Revised August 2013

Re: **Revised Survey of Asbestos-containing Materials**
Sheridan Public School
Oakville, Ontario

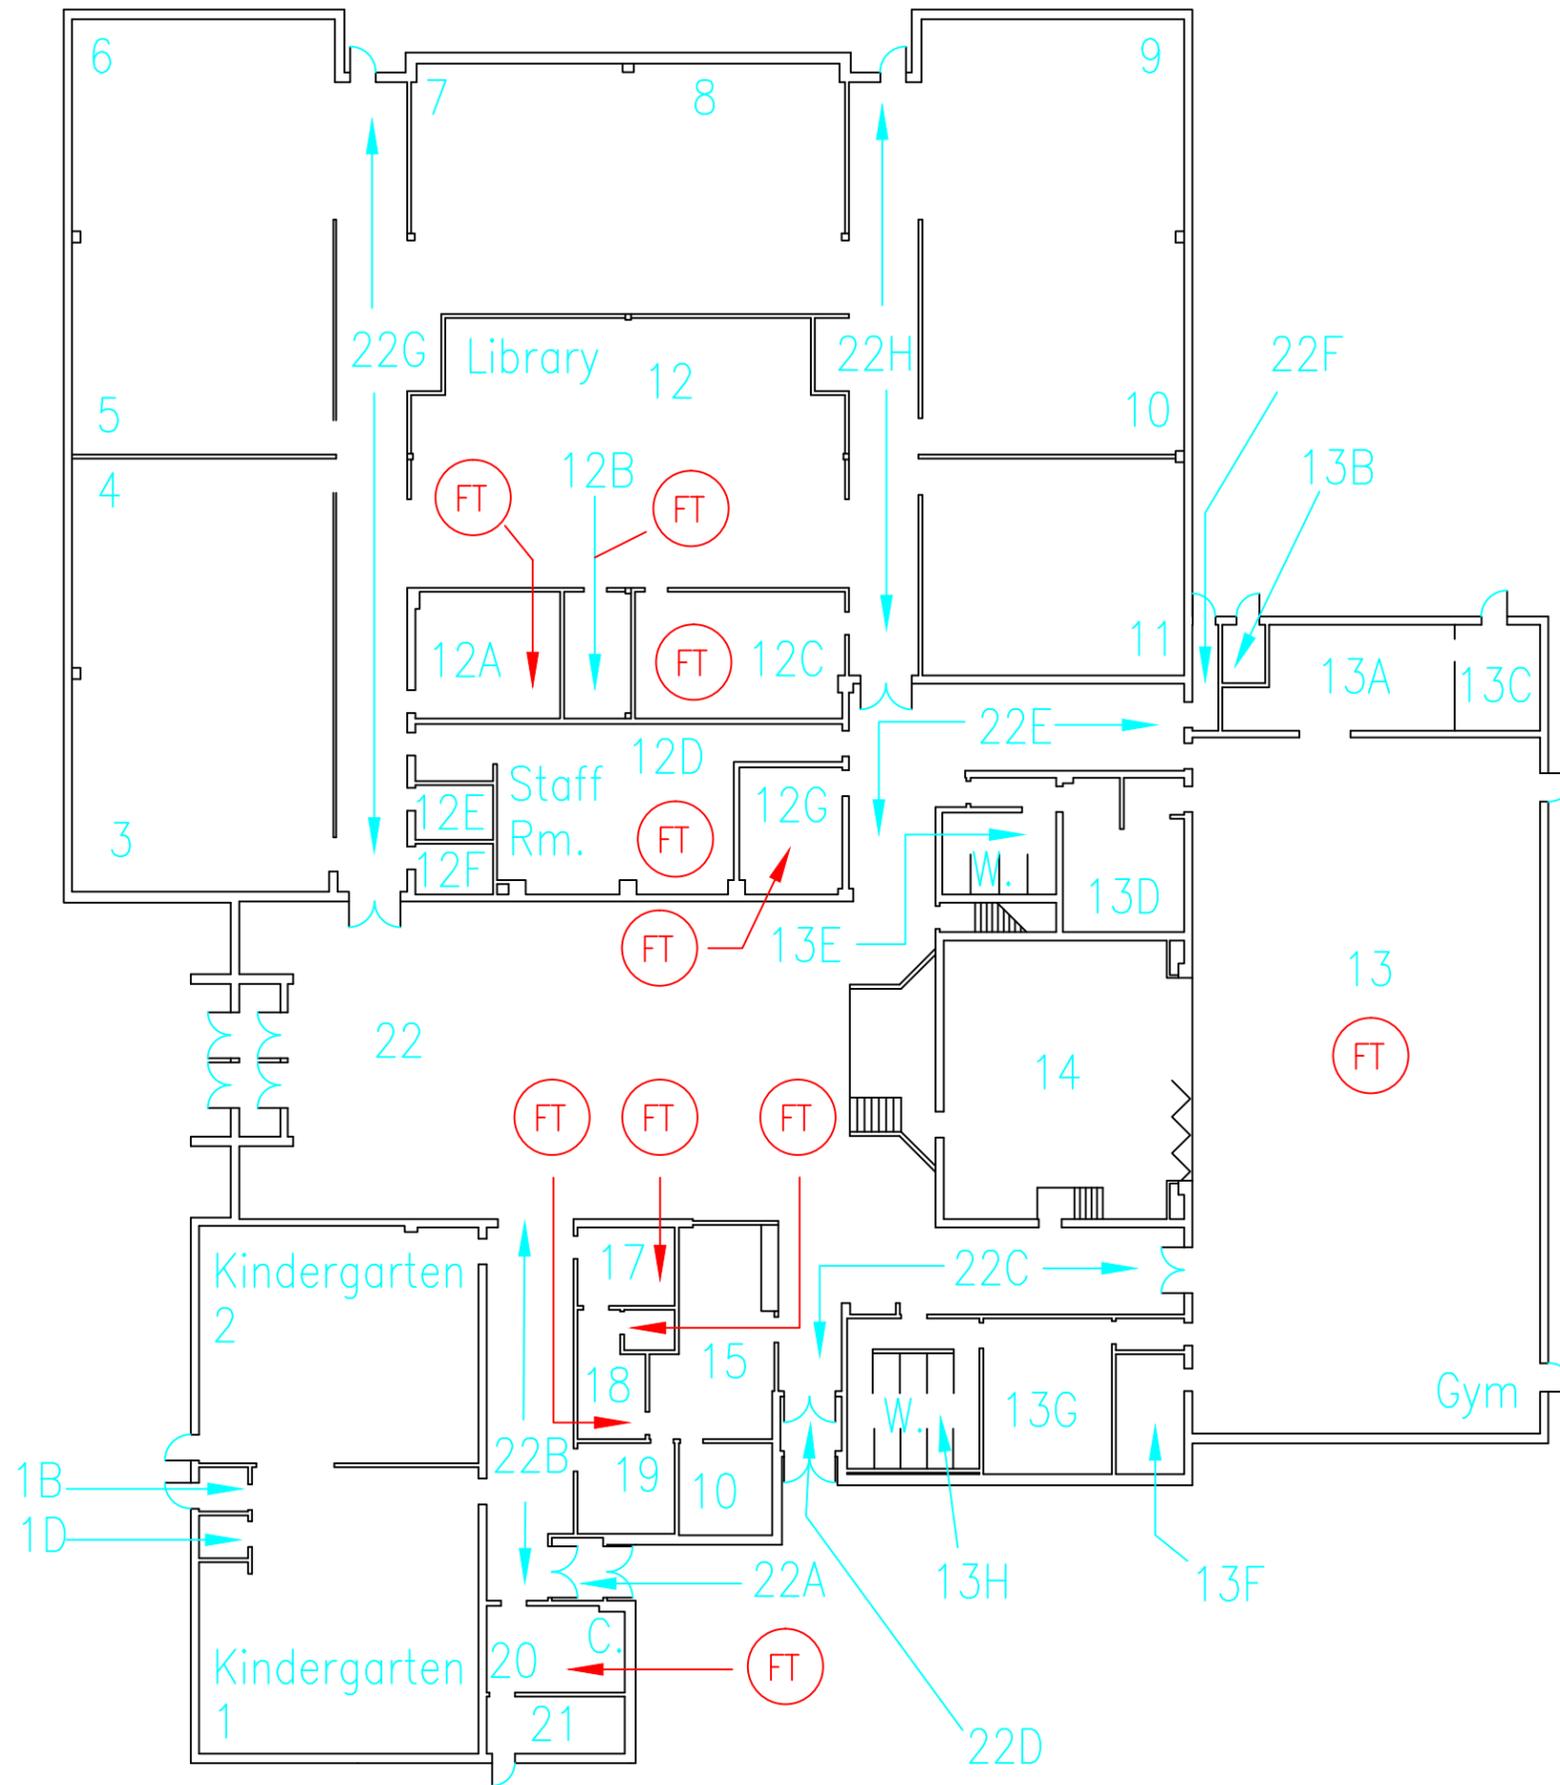
FIRST FLOOR

Non-friable vinyl flooring suspected of containing asbestos was found in various locations throughout the building.

Locations of vinyl flooring suspected of containing asbestos are identified on the attached floor plan(s).
